NWC TP 5921

Reduction of Fuel Fire Cook-Off Hazard of Rocket Motors

by
Ronald F. Vetter
Propulsion Development Department

JUNE 1977

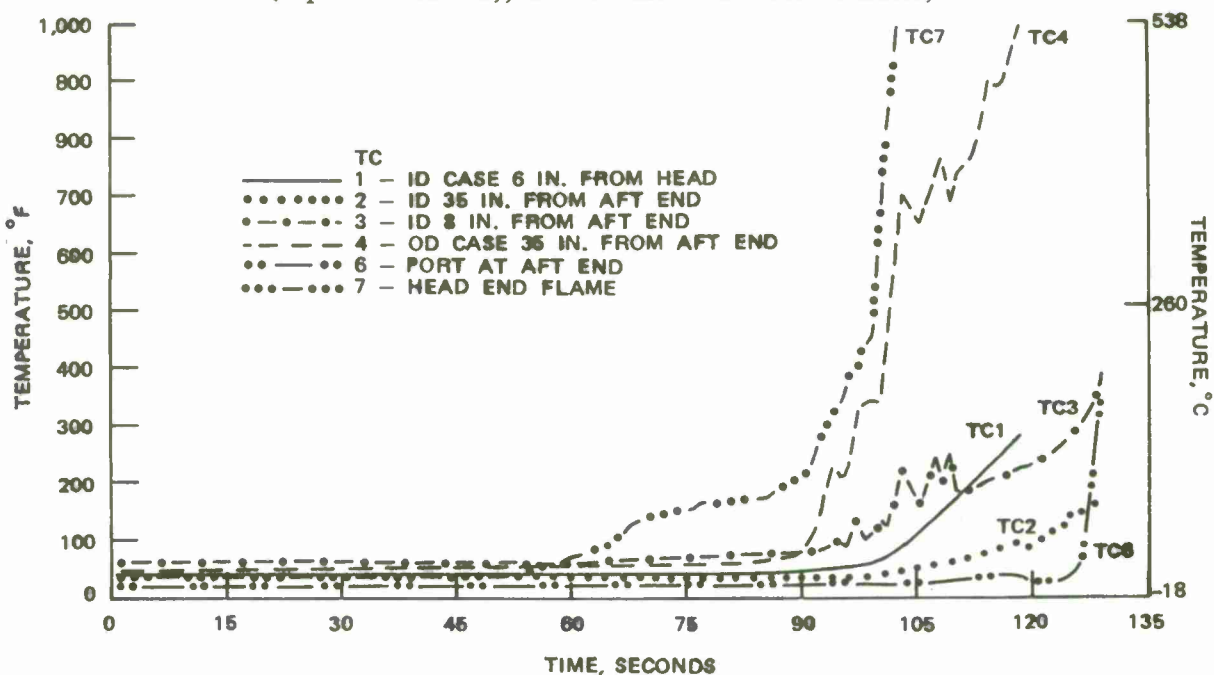
FIGURE 3. Mk 36/50 With Aluminum Rivets.

on one side. There was no enlargement or melting evident at these empty holes. The entire grain appears to have ejected when case rupture occurred. Movie coverage showed nothing except slowly building fire until rupture. The rupture caused ejection of small pieces (many burning) in a manner typical of pressure vessel failure; some of these pieces would have traveled over 15 meters (50 feet). More or larger holes might allow sufficient venting but then case weakening would worsen.

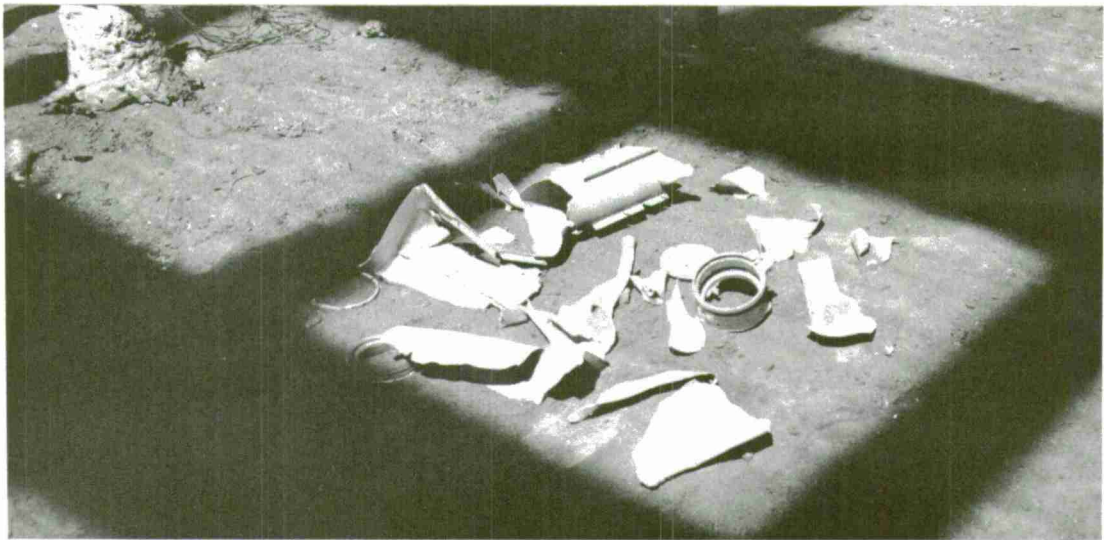
FIGURE 4. Collected Pieces of Mk 36/50 Case (LHL 187166).

Reloaded Mk 36 hardware, containing an ~ 1.3 mm thick polyether polyurethane based liner (SD-723 plus 2% Kynol fibers and 10% TiO_2), was cooked on 2 April 1975. Results were much worse than anticipated. At 50 seconds there was a violent pressure rupture of the entire case with many small pieces of flaming propellant visible in the movie. Approximately 20 fragments (Figure 4) were scattered about the enclosure and judged to have been hot but not much weakened. (This was based on the approximately 45-degree-angle of the breaks, the folded and wrinkled shapes, and ID thermocouple readings of approximately 240 and 360°C (460 and 680°F). Also, the OD thermocouple was exposed to flame and had been up to saturation and back down to approximately 590°C (1100°F) at the time of rupture.) The aft port thermocouple (Figure 5) indicated temperature rise from 39 seconds to 190°C (375°F) at 50 seconds, while the head end port lagged considerably (start-up at 48 seconds and reaching 85°C (185°F) at 50 seconds). This strongly indicates gases entering the port at the aft end and igniting the bore surface. Both thermocouples were saturated ($> 1315^\circ\text{C}$, 2400°F , at 51 seconds) then went negative; which may mean ignition and loss of continuity at rupture. (The previous test motor, which had the same porous propellant and nonstandard aft end configuration, lost the head end port thermocouple before the test but the aft end temperature rise was similar—it rose a bit more rapidly and reached 232°C (450°F) at 129 seconds, 428°C (803°F) at 130 seconds, and was negative (disconnected) at 131 seconds.) The decision not to use standard casting procedures and tooling (due to difficulty with thermocouple wires and not wanting to modify the tooling) apparently resulted in less pyrolysis gas confinement and propellant voids. This is evidenced by the fact that aft end bonding failed; this would not be expected in the normal configuration which has a preformed aft insulation bonded to the matching aft grain face normally formed by the casting tooling. Also, in the normal configuration, this bond is usually reinforced by a compression fit when the nozzle is inserted. The poor propellant physical properties and the extra strong nozzle closure may also have contributed to the high pressure. In summary, the sample was considered inferior but does demonstrate the importance of fore and aft bonding to seal pyrolysis products and keep them from entering the bore.

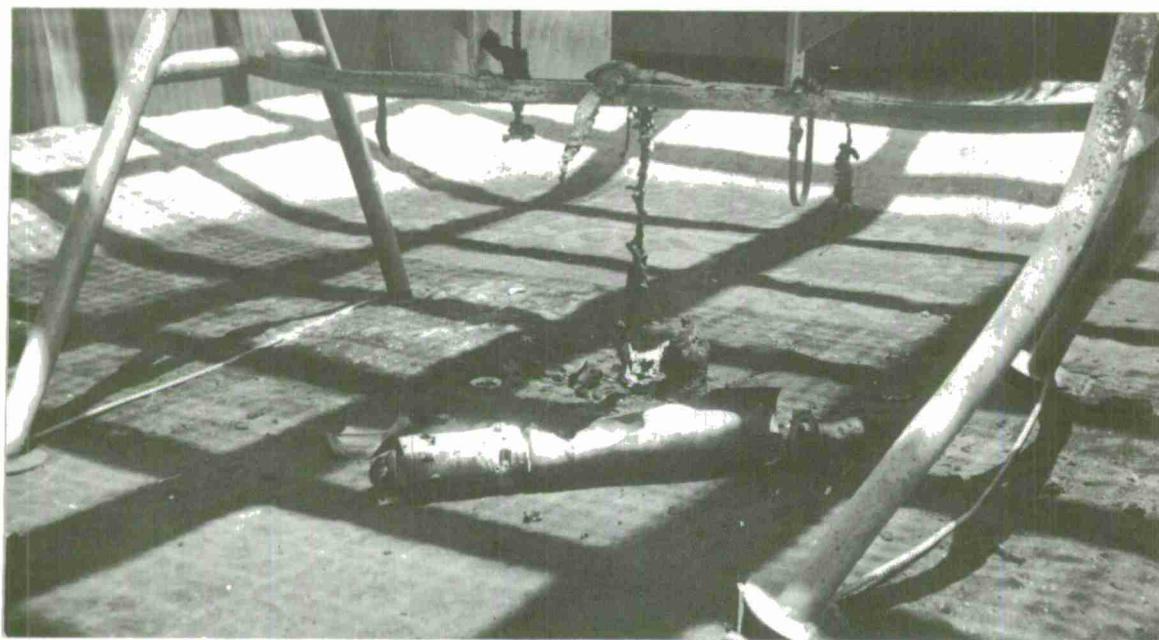
FIGURE 10. Post-Test View of Mk 52 With LR-13 Liner (LHL 188114).

A bulge of heated, thinned steel on the right side of the head end may have been the initial rupture point; apparently causing the motor to jump forward and left, removing it from the small simulated "rail" and loose strap around the nozzle which

suspended it from the A-frame. At any rate, when the motor fell it pulled the nozzle plug and thermocouple wires out and opened a path to the propellant bore. A single hot piece of case wall, which included some of the thinned metal, was ejected from the forward top right side of the motor and hit the horizontal beam of the A-frame causing the hot piece to deform to the shape of the beam. This could have been either when the soft area initially opened (causing the hot case wall material to be flung up to the beam, wrapped around it and held by it when the rest of the motor was pushed away by the pressure of the propellant grain and burning, expanding gas) or after the motor was on the deck.

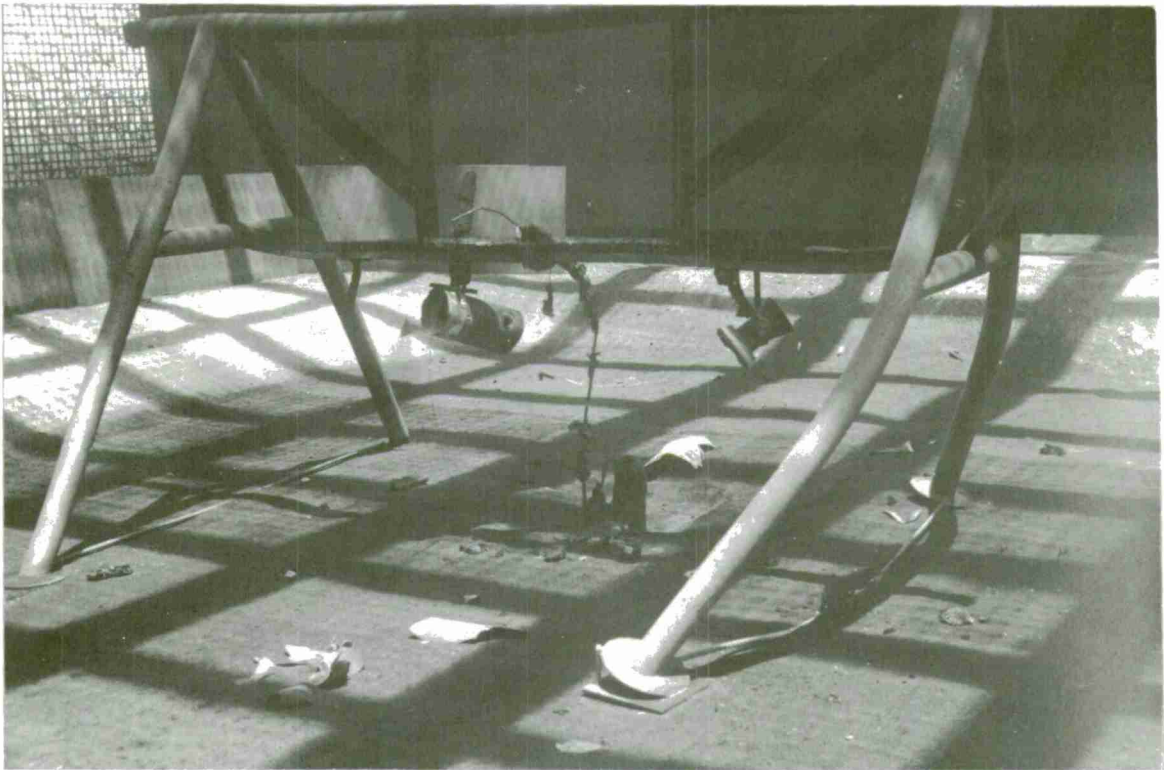
FIGURE 12. Mk 52 Case With CTPB Liner and Low Smoke Propellant After Cook-Off (LHL 188175).

The cook-off fire was good with near zero wind. Four thermocouples were located (per MIL-STD-1648(AS)) at motor height about 8 inches in each direction from the item. These thermocouples reached 870°C (1600°F) at 27 seconds and remained there, or above, past the 50 second time of first reaction. Noises monitored were a "pop" at 50 seconds, a burning sound at 51 seconds, and much flame and burning at 54 seconds. Burning continued to 77 seconds with a change in tone and lower volume also at 70 seconds.

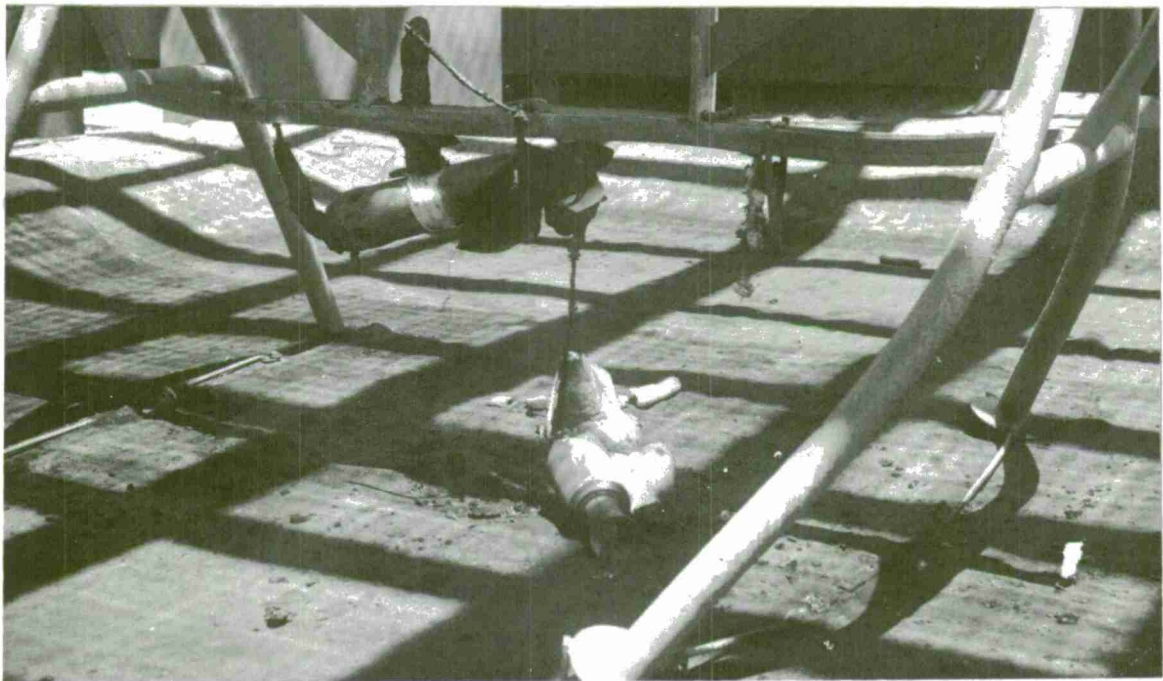
FIGURE 15. Mk 52 With LRV-1 Liner and RV-13 Propellant After Cook-Off Fire (LHL 188176).

The expectation that this liner would yield the least violent reaction was not met nor was the liner/case pressure measurement as expected. The latter may well be due to equipment and technique shortcomings. The reaction must be considered a deflagration since the grain segment could have traveled on the deck more than 15 meters (50 feet). The flight of the nozzle, case and grain thus means the test failed to meet the goal.

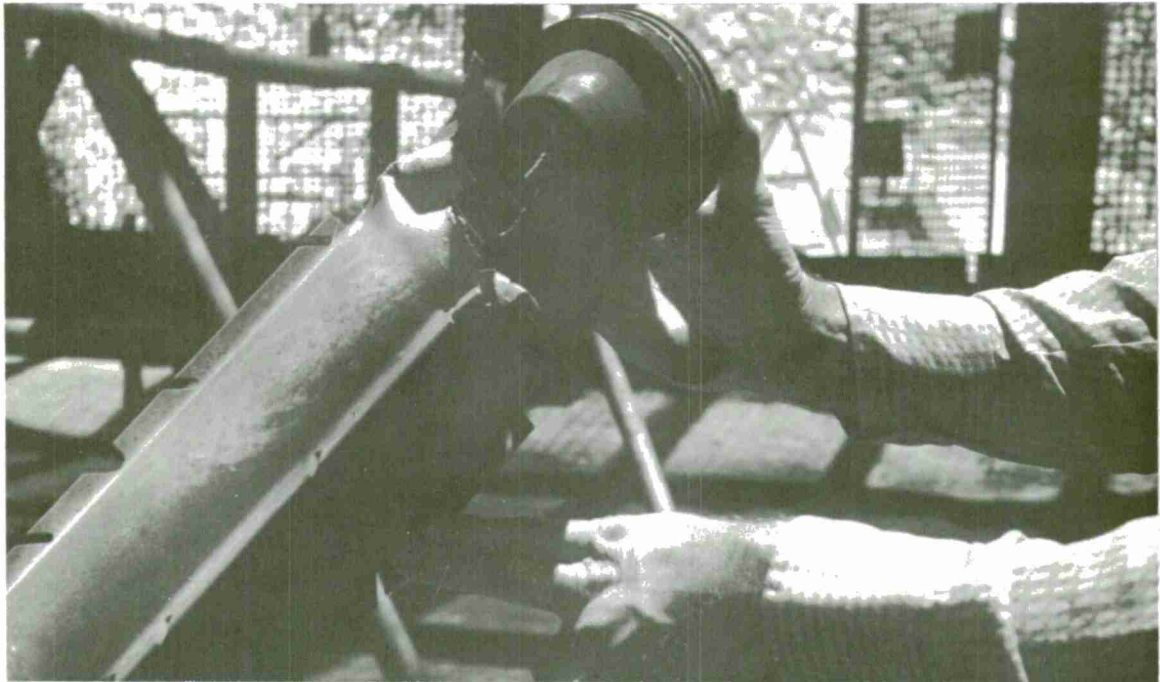
FIGURE 16. Mk 36/50 Case After Cook-Off Using HTPB Liner and Smokeless Propellant (LHL 188214).

The pressure gauge was attached to a fitting welded to the case OD 63 cm (25 inches) from the head end with a hole through to the liner OD. It showed a small pressure (approximately 51 kPa) from 163 to 183 seconds. At 184 seconds it went negative. The nozzle seal was gone and char was formed on a portion of the outer insulation. A small amount of metal-edge-rounding over this same quadrant indicates some hot gas leaked aft past the lockwire groove. The absence of an O-ring may, therefore, have contributed to a pyrolysis gases leak path which relieved pressure and grain deformation.

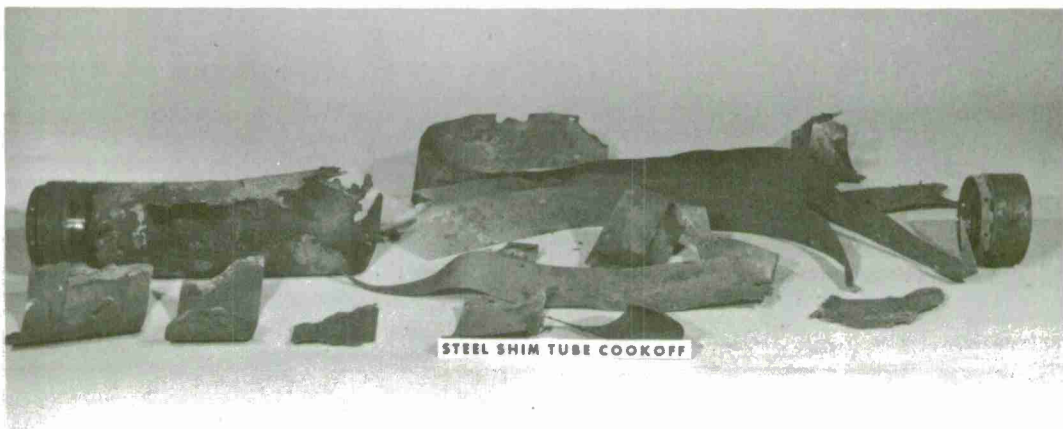
FIGURE 21. Remains of Laminated Steel Spiral Wrapped Tube Cook-Off Test No. 1 (LHL 192362).

It is difficult to do more than conjecture that some propellant surface area ignited at about 101 seconds (see Figure 23) and that the movement of the grain (allowed by failure of the closed end) toward the rupturing end allowed gas to enter the bore. Pressure on the grain OD caused it to deform inward and against the aft (open bore) end taper. Failure of the closed end then would vent the forward end pressure, providing the force to hold the grain against the aft closure. This means that the case failed before the gases leaked into the bore, i.e., the bore was not ignited prior to failure.

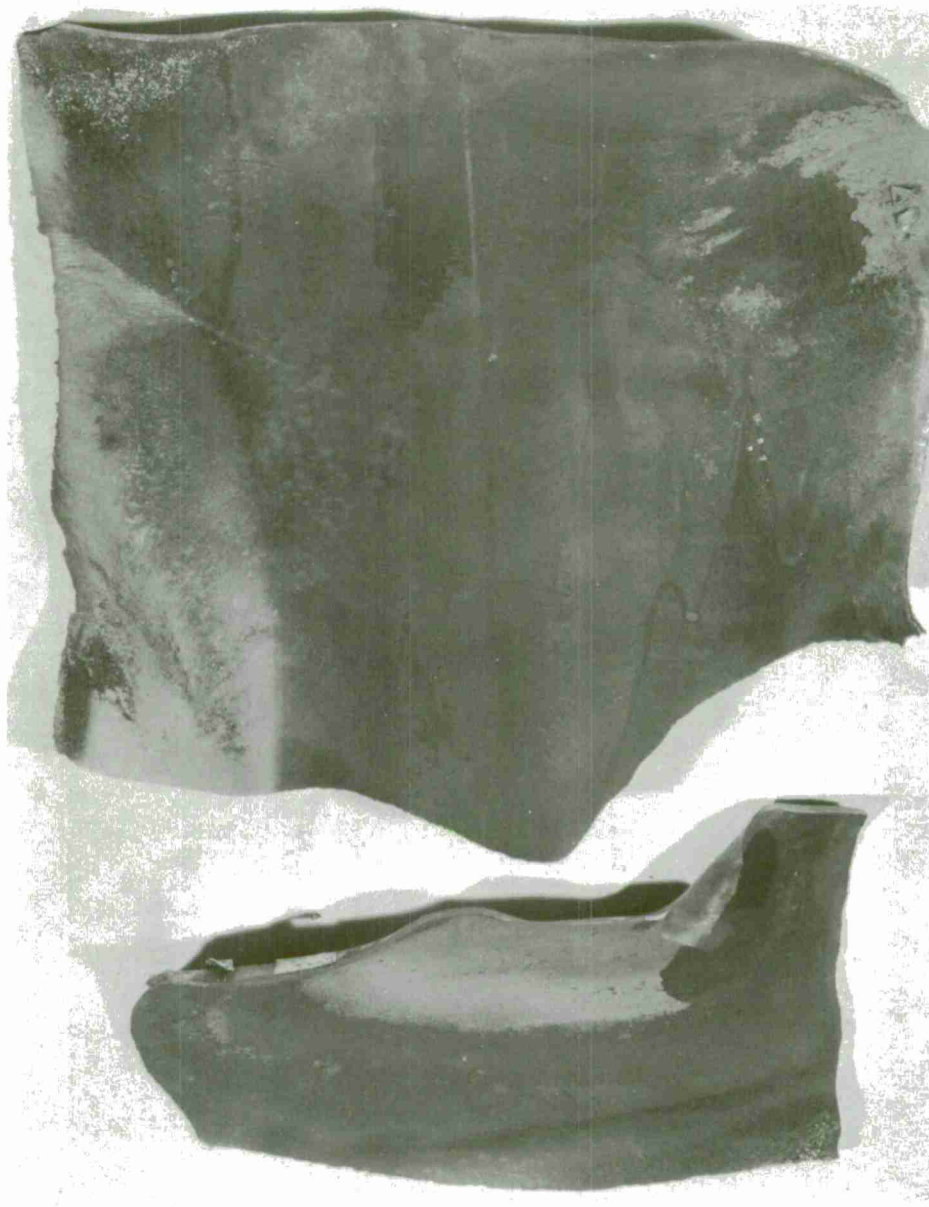
FIGURE 31. Test Section Case Well Ejecta (LHL 192377).

At about 62.4 seconds, both pressures very rapidly collapsed to zero and near zero; which must correspond to the case rupture. The pressure was 2.58 MPa (375 psi) at the case/liner measuring location and 2.28 MPa (330 psi) in the bore. The bore pressure went from 34 kPa (5 psig) at 63 seconds (after rupture) to 21 kPa (3 psig) at 80 seconds; which corresponds to the time the jetting-noise-of-burning increase was recorded on the videotape. The pressure then came up to 76 kPa (~ 11 psi) at 80.7 seconds and dropped slowly to 14 kPa (2 psi) at 86 seconds (Figure 30). The case/liner pressure dropped to -34 kPa (-5 psig) at 86.3 seconds. This corresponds in time to the observed dropping off of the grain segment and case head end (cantilevered from the case aft end which was mounted to the test support).

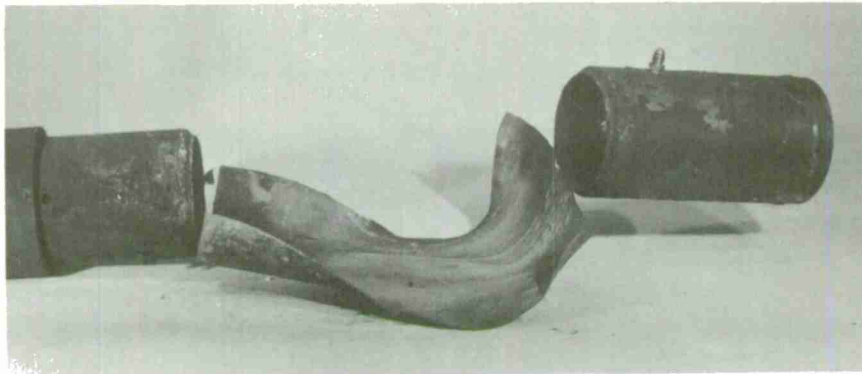
FIGURE 35. Dual-Lined Extended Model Motor Case After Cook-Off Test (RV-7 Propellant)(LHL193542).

A steel model motor lined with thin painted coatings of SD-723 polyether polyurethane and then HTPB-based liner and cast with low smoke HTPB propellant was "cooked" over the propane burners. Figure 35 is a post-test photograph showing the split along the entire bottom of the test item. A small area of the metal was stretched (thinned) at the initial failure site. The rupture occurred at 73 seconds with bottom forward case/liner pressure exceeding 3.4 MPa (500 psig) just prior to the bore reaching 3.25 MPa (472 psig). At 72 seconds, a higher rate of pressure rise started and was postulated as due to a small area of propellant igniting with a much higher rate of gas production. The bore was collapsed by this external pressure on the propellant cylinder which continued until the case ruptured. This round-bore test item is not typical of rocket motors in the sense that there is no stress concentration upon bore collapse such as that involved with a typical star-shaped grain perforation. This means that the model motor has mechanical strength failure modes that are different from a tactical rocket: (1) stronger intrinsic grain as elaborated, (2) excellent fore and aft sealing on the grain OD, and (3) a solid closure rather than a weather seal closure in the nozzle. The nozzle closure will normally fail at a nominal bore pressure of perhaps 1.2 MPa (200 psi) and thus reduce the grain support by removing the internal bore pressure. This means that some tactical motors would react more violently than the

model motor because the propellant grain wall (web) would tear, thereby allowing internal bore ignition which would tend to throw propellant and case fragments much more violently.
